[REDACTED] **Project**

Survey Reference: [REDACTED]

7th – 10th December 2020

LOADING REPORT

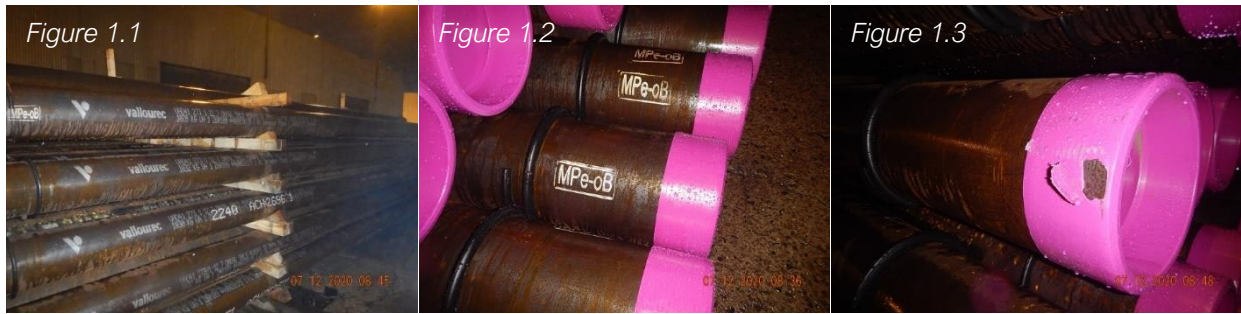
1. Very light surface rust was observed on all units. No pitting or concerning oxidation was seen.
2. Some pipe end caps were damaged, with splits, cracks or punctures. All pipes found with damaged end caps were checked for damage to the steel below, none was found. Pipe end caps found damaged were repaired or replaced.
3. Two pipes were found missing rubber spacers. One spacer was found and replaced the other was replaced with 20mm polypropylene rope tied around the pipe.

Figure 1.1 Figure 1.2 Figure 1.3
Pipe Markings – Spacers, End Caps & Test Marking – Damage to end cap

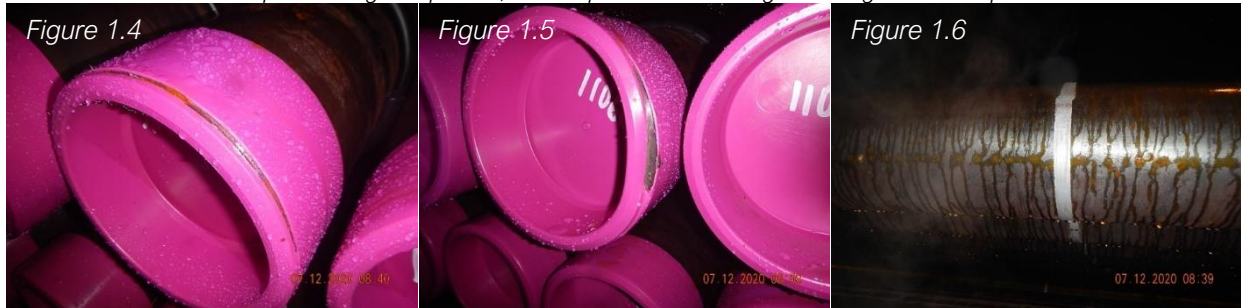
Figure 1.4 Figure 1.5 Figure 1.6
Damage to end caps – pipe join and steel condition

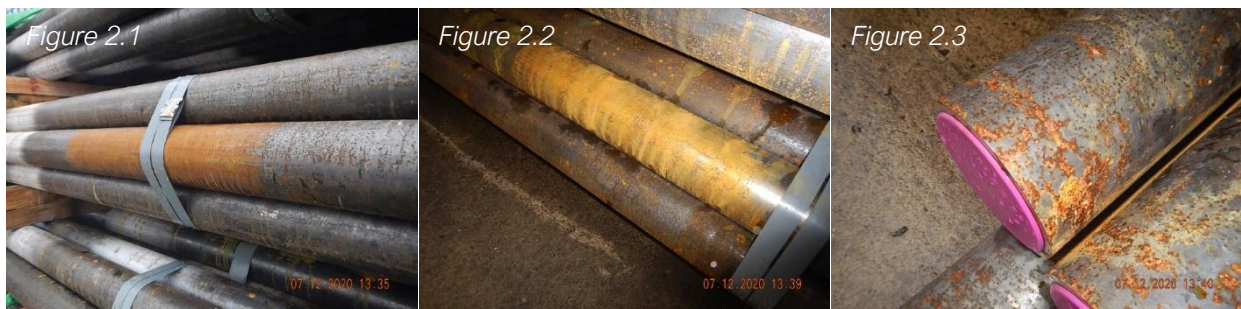
1. Very light surface rust, externally and internally, was observed on all units. No pitting or concerning oxidation was seen.
2. Some pipe end caps were missing, these were replaced.
3. Many 114.3mm pipes were found with 101.6mm pipe end caps, leaving the pipe end edges exposed
4. Steel securing bands all found in position and in good order
5. Fibre webbing lifting slings all found present and in good order

Figure 2.1 Figure 2.2 Figure 2.3
Bundle straps – Steel condition, light oxidation

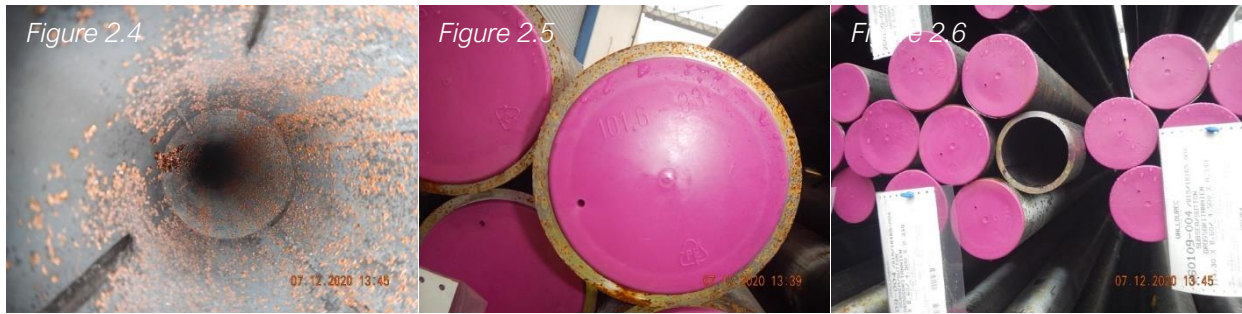
Internal condition – 101.6mm end caps fitted to 114.3mm pipes – Missing end caps

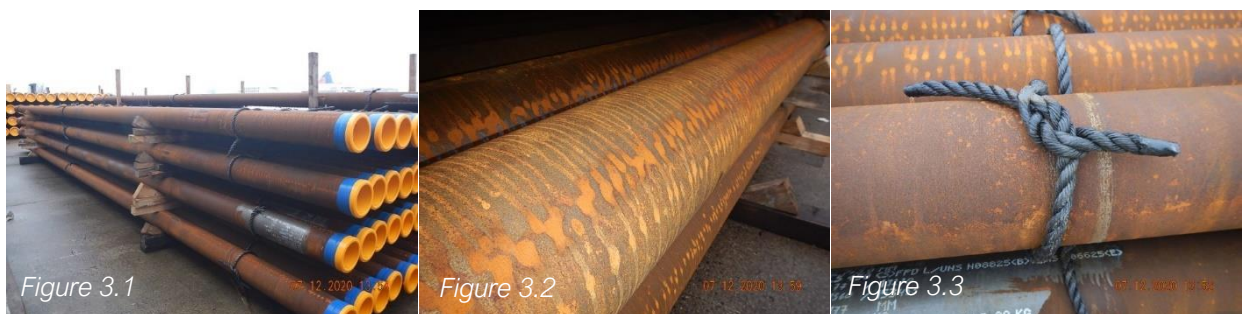
1. Light surface rust was observed on all units. No pitting or concerning oxidation was seen.
2. Some pipe end caps were damaged, with splits, cracks or punctures. Many pipes with such damage had been previously repaired with waterproof tape. All remaining pipes found with damaged end caps were checked for damage to the steel below, none was found. Pipe end caps found damaged were repaired.

Pipe steel condition – Rope spacers

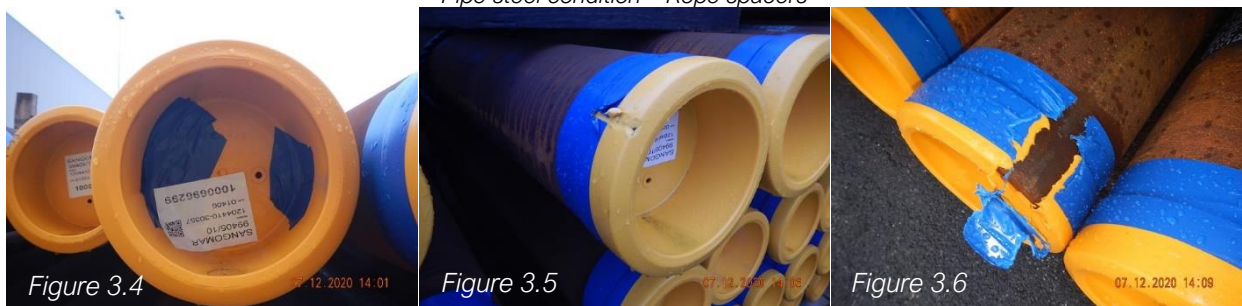
End caps with repairs – Damage to end caps and tape

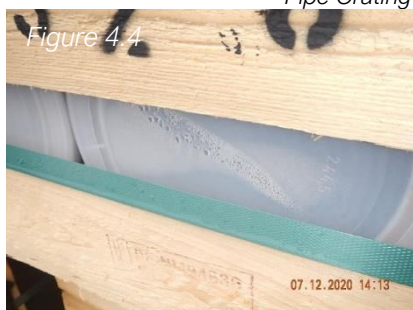
Figure 4.4

1. Light surface rust was observed on all units. No pitting or concerning oxidation was seen.
2. Some crating was found with light damage or broken away, this was not believed to compromise protection to the cargo and was repaired where possible.
3. Some crating was found loose with securing straps loose. All crating was resecured.
4. Small amounts of moisture was observed below the pipe end caps. This was not believed to be detrimental to the cargo as no markings indicated vulnerability.

Moisture below end cap – Minor damage to crating

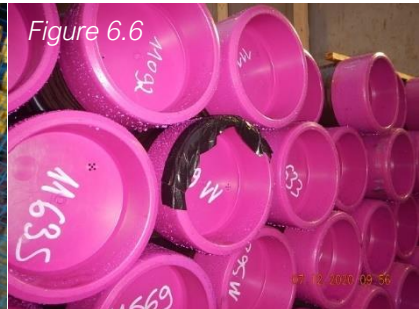
Figure 6.6

Pipe pre-loading stow and checks – tape repairs to [redacted] and [redacted] Pipes

Once moved from the storage area the pipes were rested on steel temporary storage beds beneath the gantry crane. The storage beds were inclined steel girders protected with dunnage. Here the stevedores visually checked each pipe for any damage, missing end caps or missing spacers. The securing of end caps was ensured with each cap being checked and housed with rubber hammers. Missing end caps were replaced and broken caps were repaired with tape.

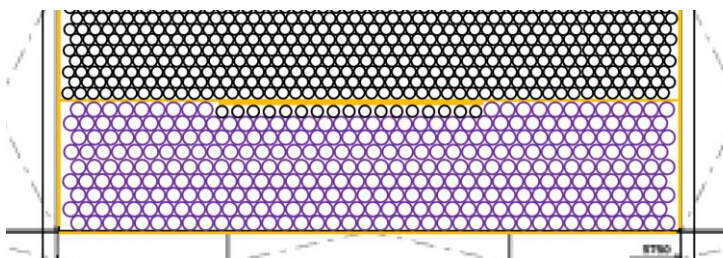
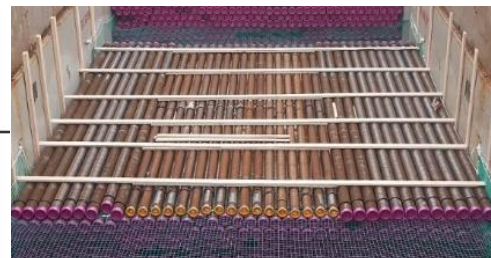
The 9th row of stack 2 was made up of 21 [REDACTED] 10' pipes and 17 [REDACTED] pipes. This left a void measured at 50mm. The void was filled with six [6] rows of 50mmx200mm timber dunnage

Stowage Plan Rev.07, Stack 2 – Dunnage layout row 9, stack 2

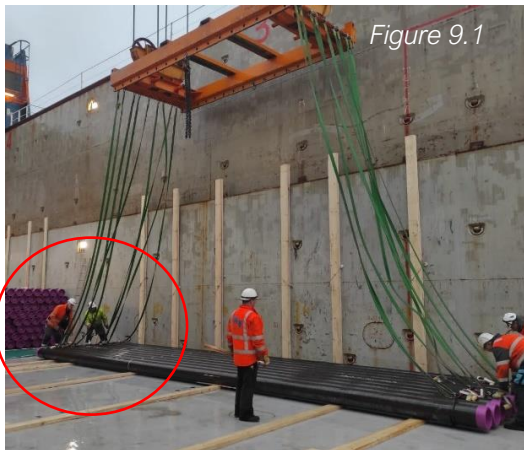
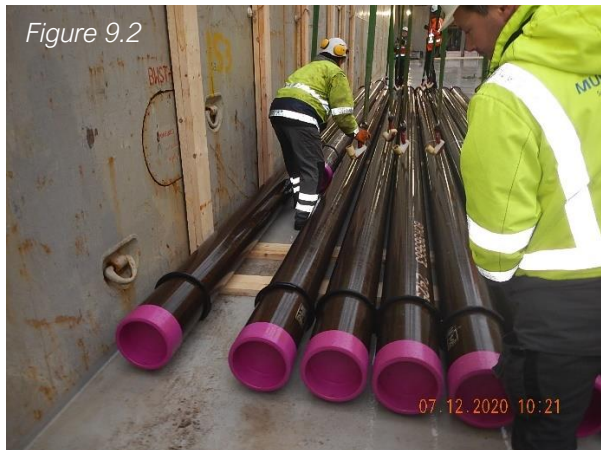
Immediately on sighting the issue, the stevedore at the hooked end shouted ‘STOP’. The banksman immediately relayed the order to the crane operator via radio, however, in the time taken for the crane operator to receive and carry out the order, the pipe was lifted to the stated height. On falling, the pipe impacted one [1] other pipe before settling on the dunnage. All men were well clear of the pipes at the time, with the two hook stevedores moving well clear on the first warning call ‘STOP’. No persons were contacted by the cargo and none injured.

Shot taken just prior to incident – Shot taken immediately following incident

1. Hooks to be removed and placed past the 2.5m marker, from the pipe end.
2. The correct removal of the hooks and clearance from the pipe ends would be verified by a second independent person.
3. The crane operator would recover the hooks at slow speed until clear of the cargo before then increasing the rate of recovery.

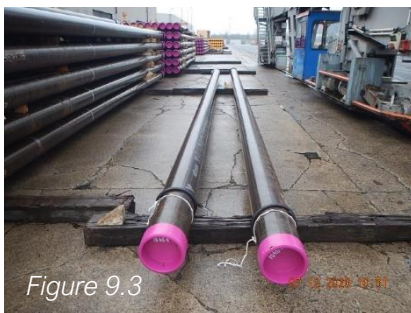
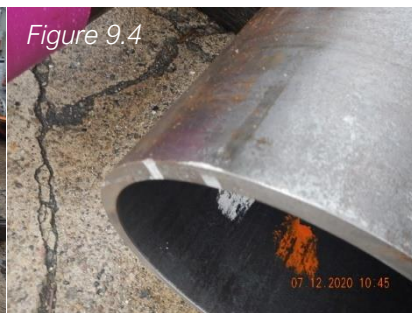
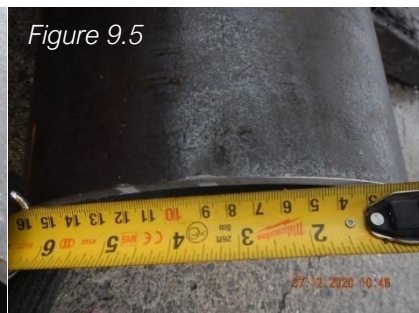
The dropped pipe; 10463/81518165 and the impacted pipe; 104648/81518165, were fully inspected for damage. The only mark found to 10463/81518165 was a 20mm minor graze on the end of the pipe. The pipes were measured and checked for any deformation with none found. Both pipes were straight and true, as per their pre-loading condition.

No deformation – mark to 10463/81518165 – measured at 20mm

- x. The two [2] pipes involved in the incident 09:21 on 7th Dec 20, were loaded Stack 3 – 8th & 9th pipes from the port side. **It is recommended that the pipes are fully inspected and further checked by [REDACTED] on delivery.**

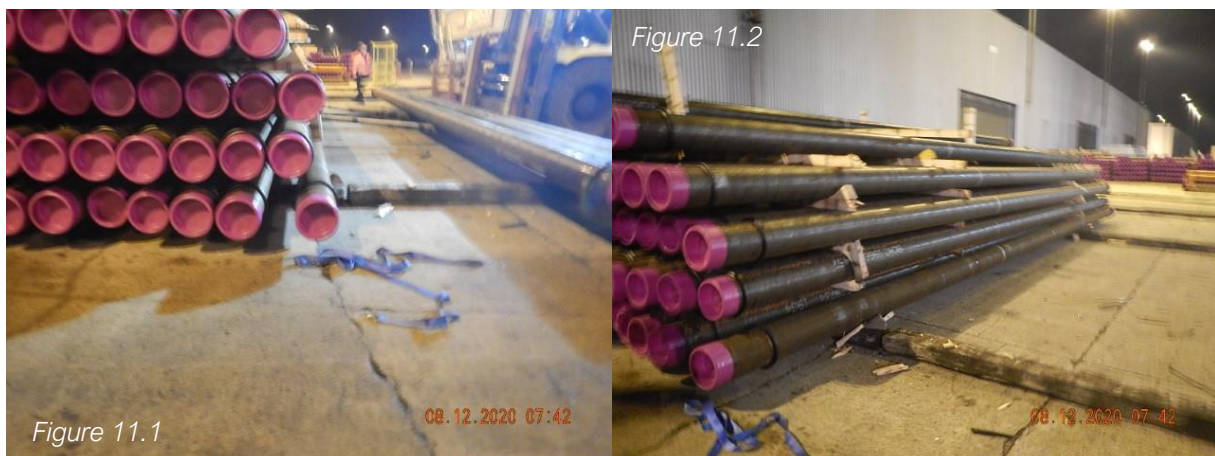
At 06:45, a fork lift attempted to pick up a set of nine [9] [REDACTED] 10' pipes. As the fork lift teeth were being positioned below the fifth [5th] stack, the dunnage framing and attached securing wedges holding the pipes broke. Three [3] pipes subsequently broke loose and rolled free from the framing, onto the teeth of the forklift. It is estimated that the pipes rolled 2-3m before bracing against the fork lift.

Picture taken on arrival at the site, 1 min after event – Broken dunnage frame

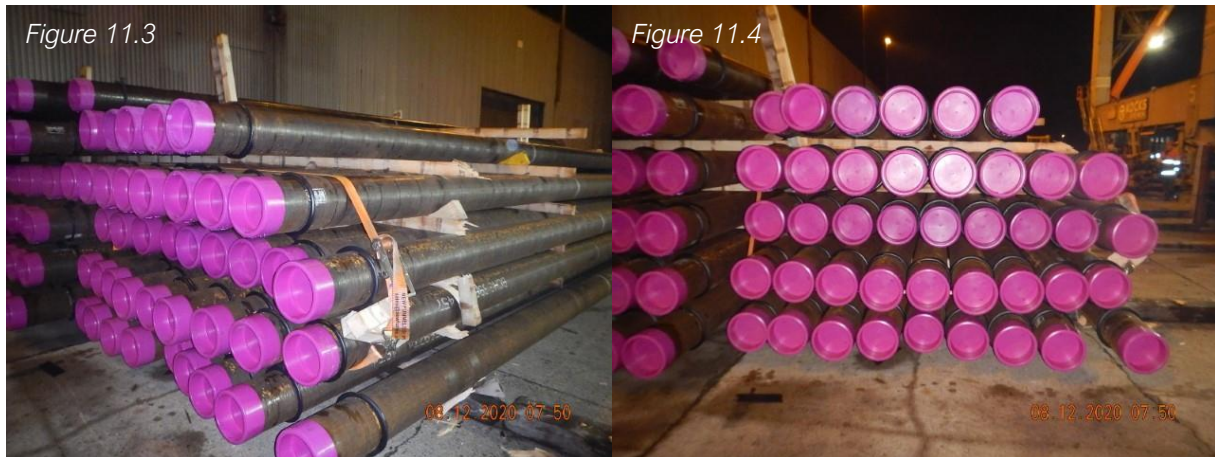
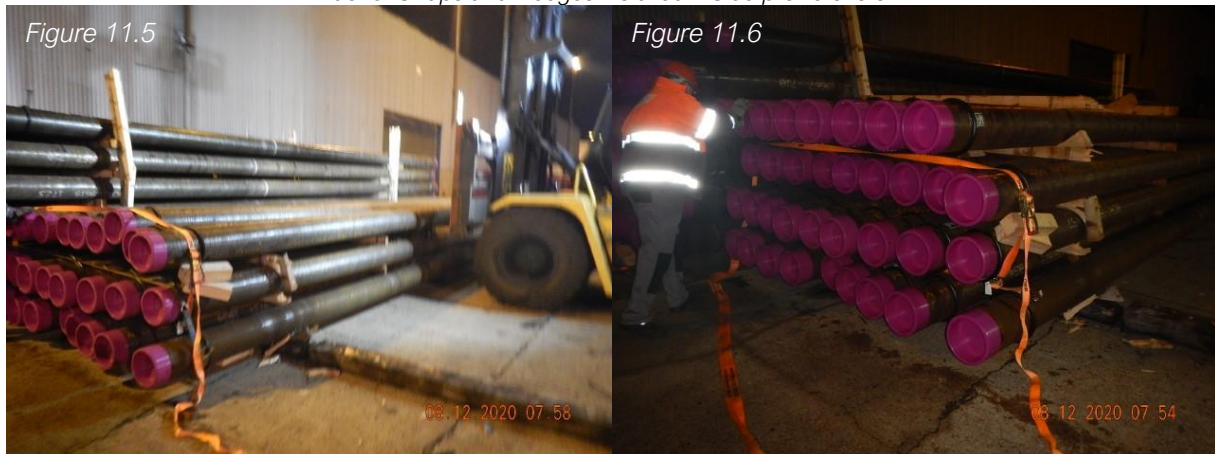
The three[3] pipes concerned were fully inspected with no signs of damage. None was expected, given the relatively minor impact.

Ratchet Straps and wedges installed – Side profile of stow

Tier by tier removal of remaining pipes
