[REDACTED] **Project**

Survey Reference: [REDACTED]

7th – 10th December 2020

LOADING REPORT

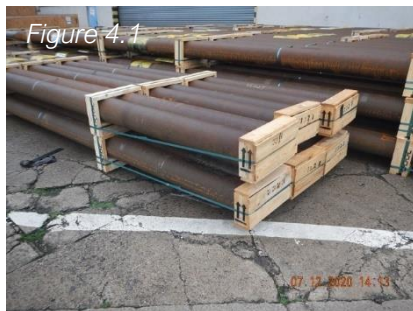
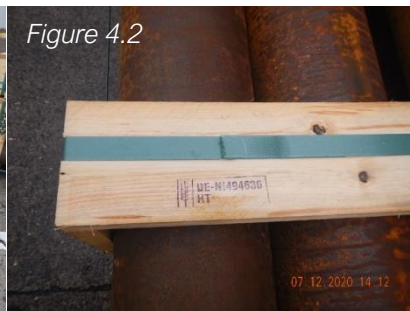
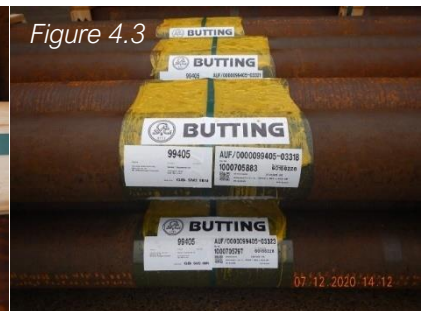
1. Light surface rust was observed on all units. No pitting or concerning oxidation was seen.
2. Some crating was found with light damage or broken away, this was not believed to compromise protection to the cargo and was repaired where possible.
3. Some crating was found loose with securing straps loose. All crating was resecured.
4. Small amounts of moisture was observed below the pipe end caps. This was not believed to be detrimental to the cargo as no markings indicated vulnerability.

Pipe Crating – Securing straps – Shipping and product Information

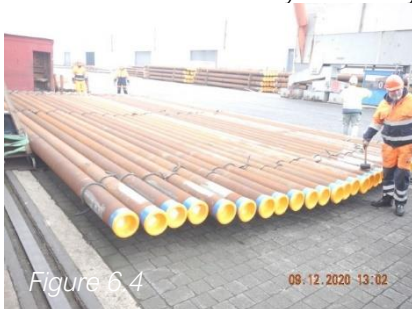
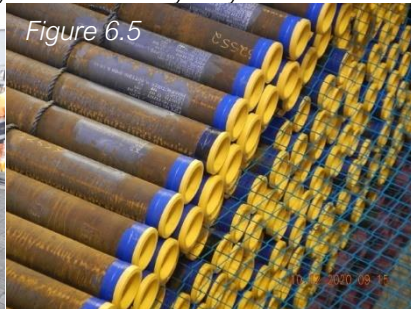
Pipe pre-loading stow and checks – tape repairs to [redacted] and [redacted] Pipes

Once moved from the storage area the pipes were rested on steel temporary storage beds beneath the gantry crane. The storage beds were inclined steel girders protected with dunnage. Here the stevedores visually checked each pipe for any damage, missing end caps or missing spacers. The securing of end caps was ensured with each cap being checked and housed with rubber hammers. Missing end caps were replaced and broken caps were repaired with tape.

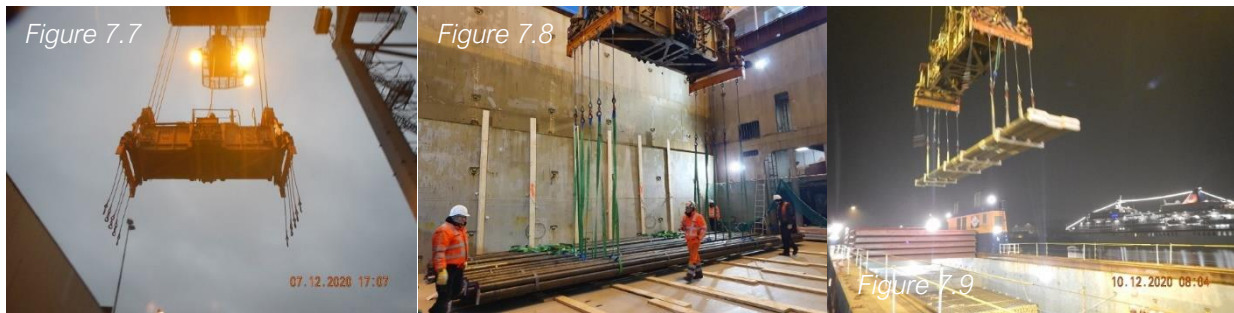
The crated pipes lifting positions marked were not used. It was believed the sling compression force would damage the crating unnecessarily. It was agreed by all, the pipes would be slung directly around the pipe surface, immediately on the inner section next to

the lifting points marked. A test lift was performed satisfactorily and the pipe lifts were continued safely without issue.

Container lifter fitted with securing bars – Slung bundles – Slung crated pipes

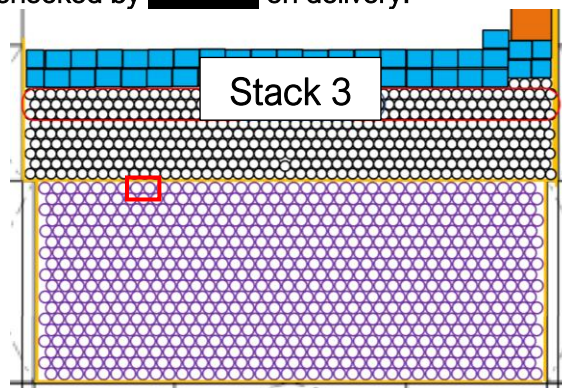
Figure 14.0

The pipes were clearly marked using checked green/white tape and were stowed for easy identification and early removal on; Stack 3 – 8th & 9th pipes from the port side. All parties involved with the discharge of the cargo will be advised of the location. **It is recommended that the pipes are fully inspected and further checked by ██████████ on delivery.**

- x. The two [2] pipes involved in the incident 09:21 on 7th Dec 20, were loaded Stack 3 – 8th & 9th pipes from the port side. **It is recommended that the pipes are fully inspected and further checked by [REDACTED] on delivery.**
